HISTORIC STRUCTURE ASSESSMENT REPORT

SNEE FARM (MAIN HOUSE)

CHARLES PINKNEY NATIONAL HISTORIC SITE
Mount Pleasant, South Carolina

1997

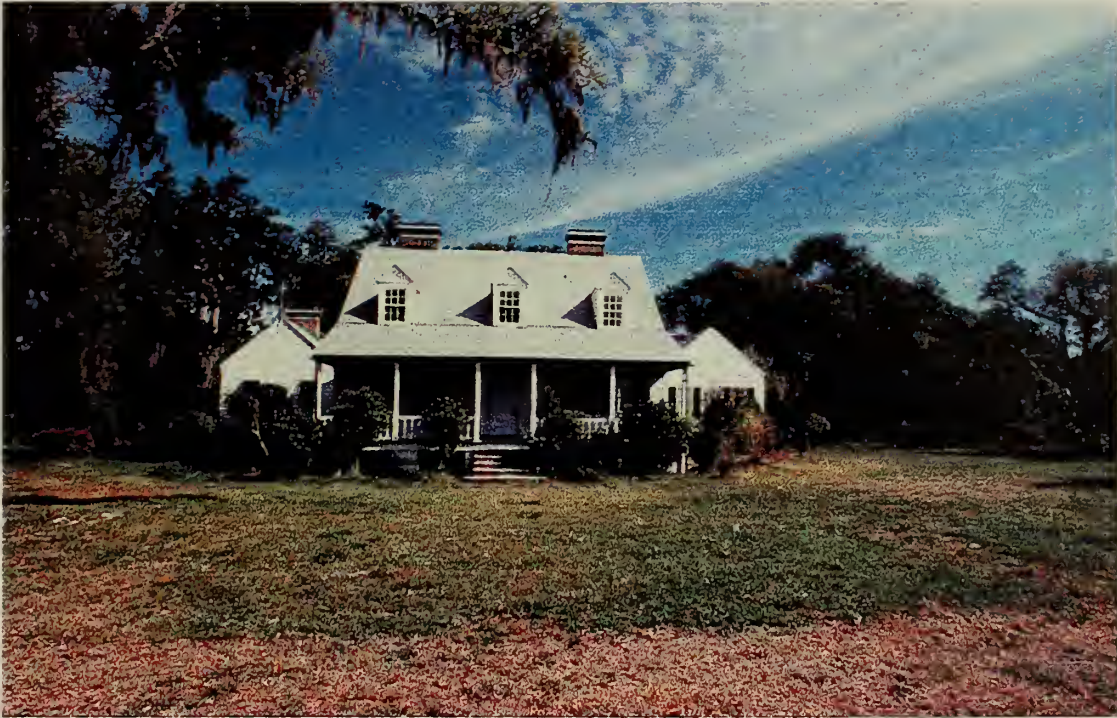
South elevation.

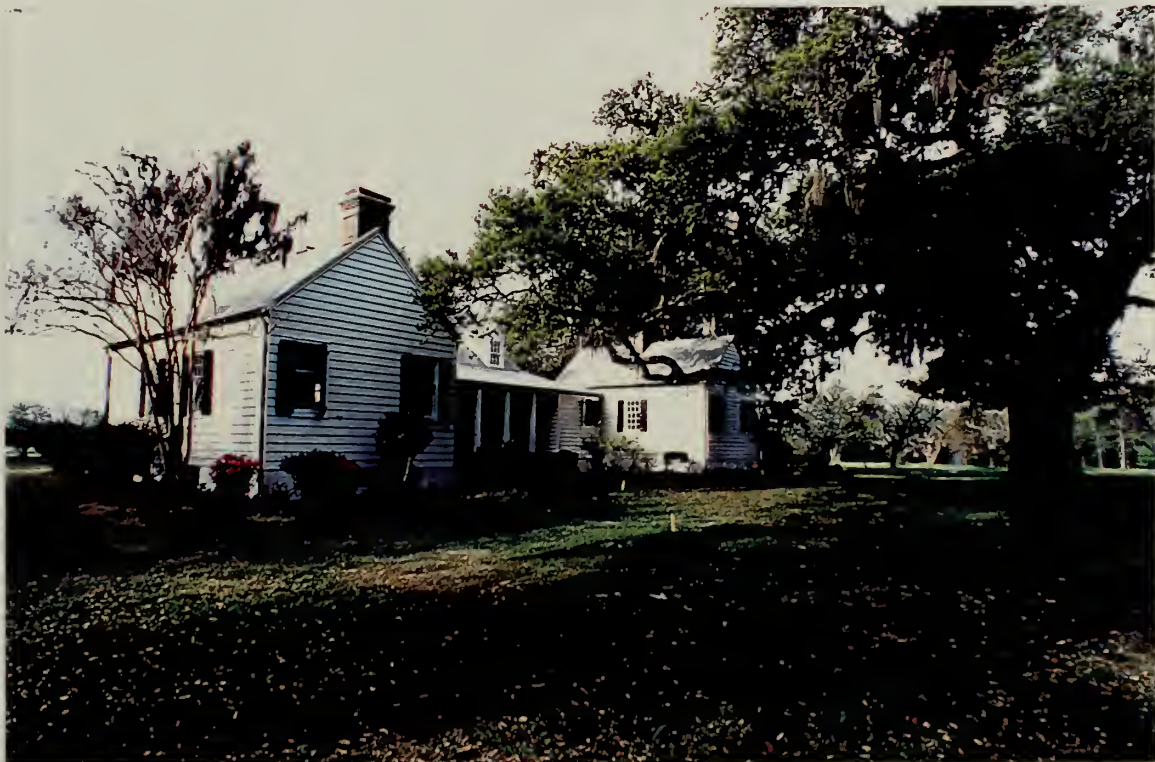
Northeast elevation: note the east and west wings.

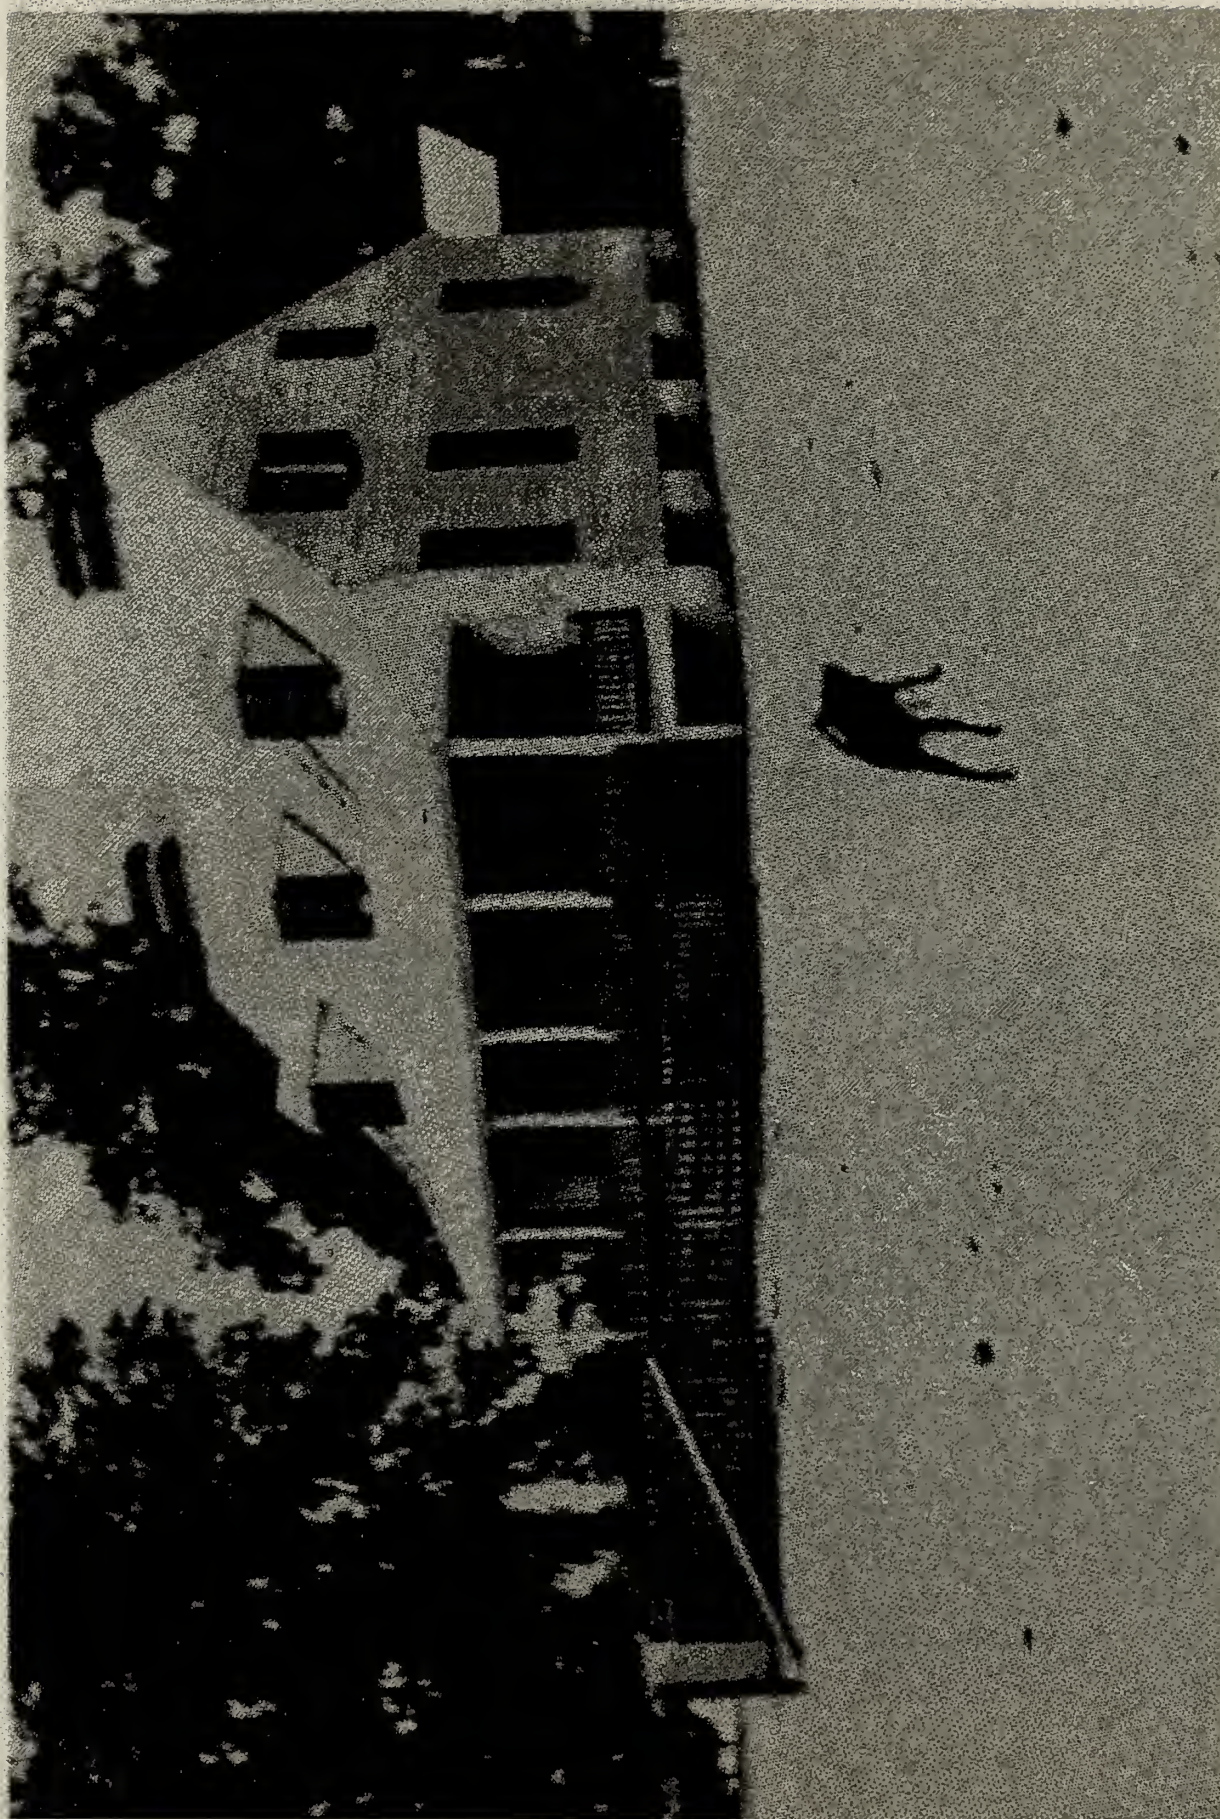
Southeast view of the main building before the addition of the east and west wings

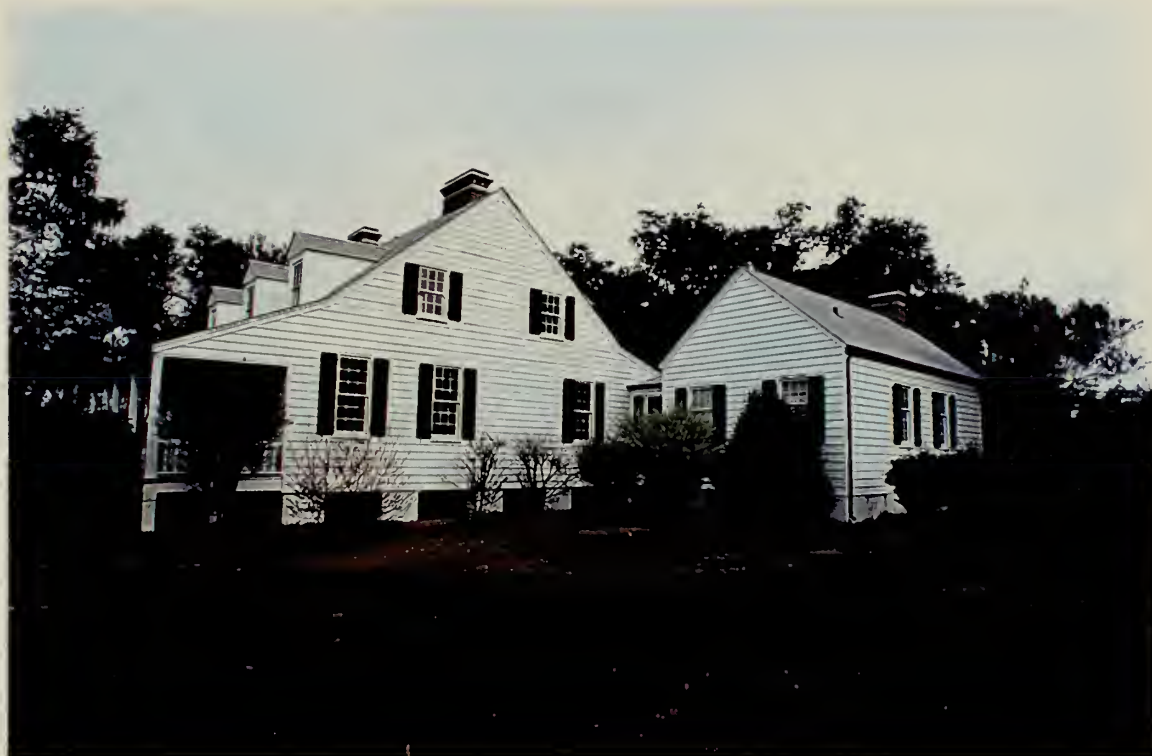
Southeast elevation.

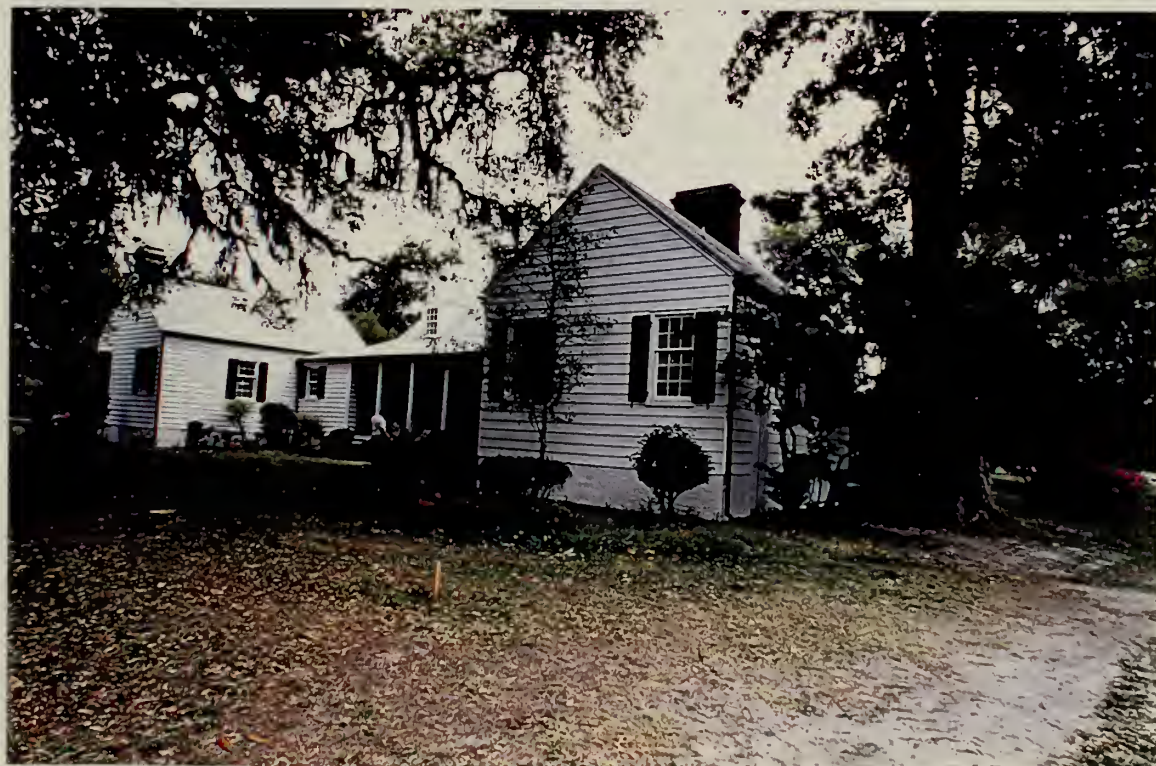
Northwest view with east and west wings.

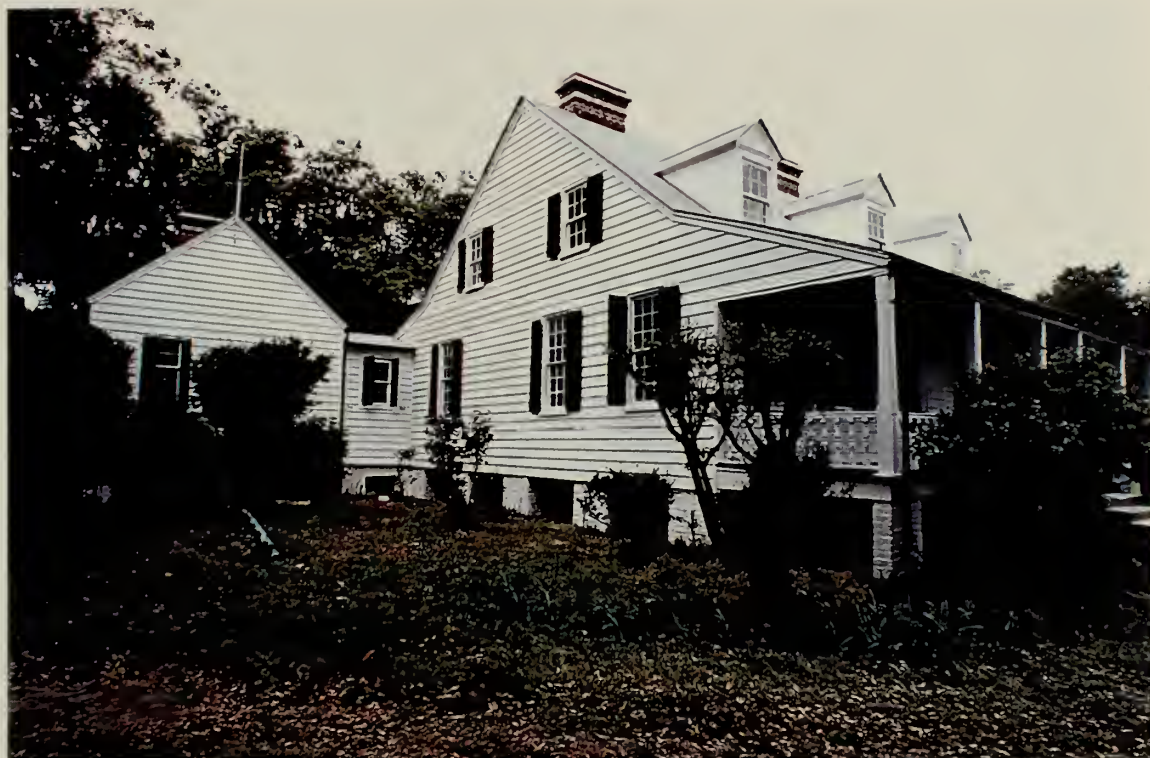
Southwest elevation: note the west wing of the main house.

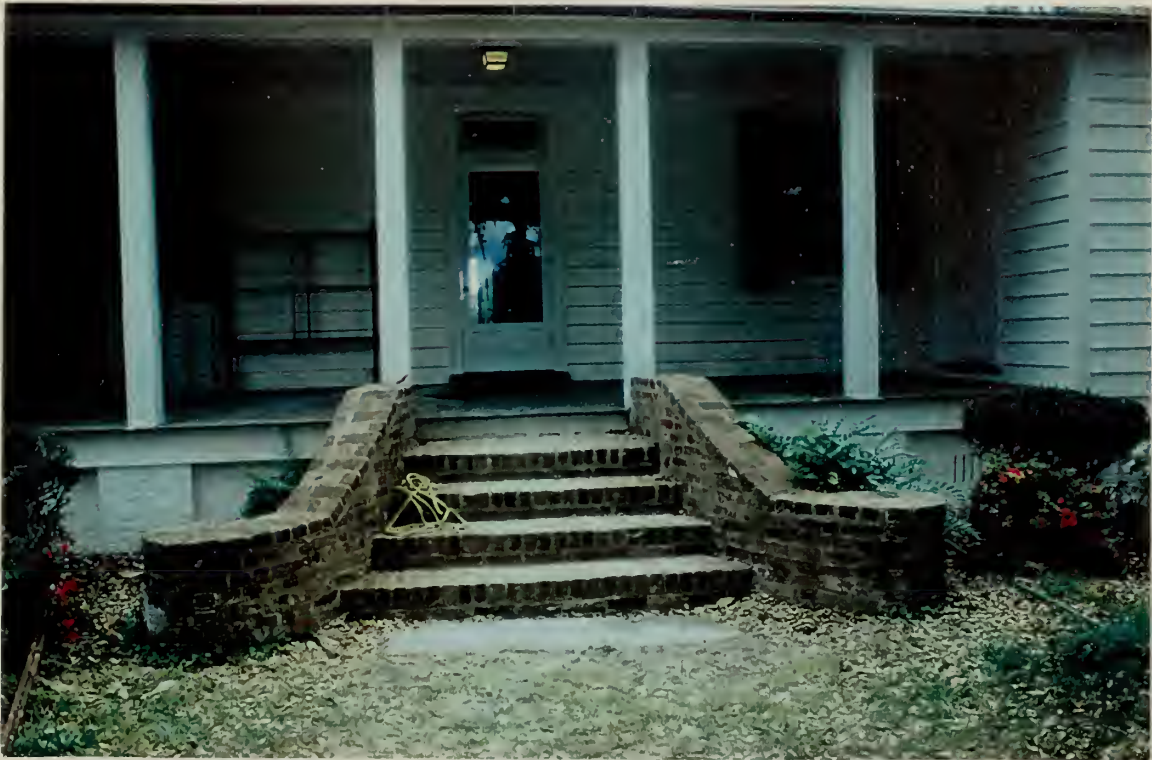
West elevation.

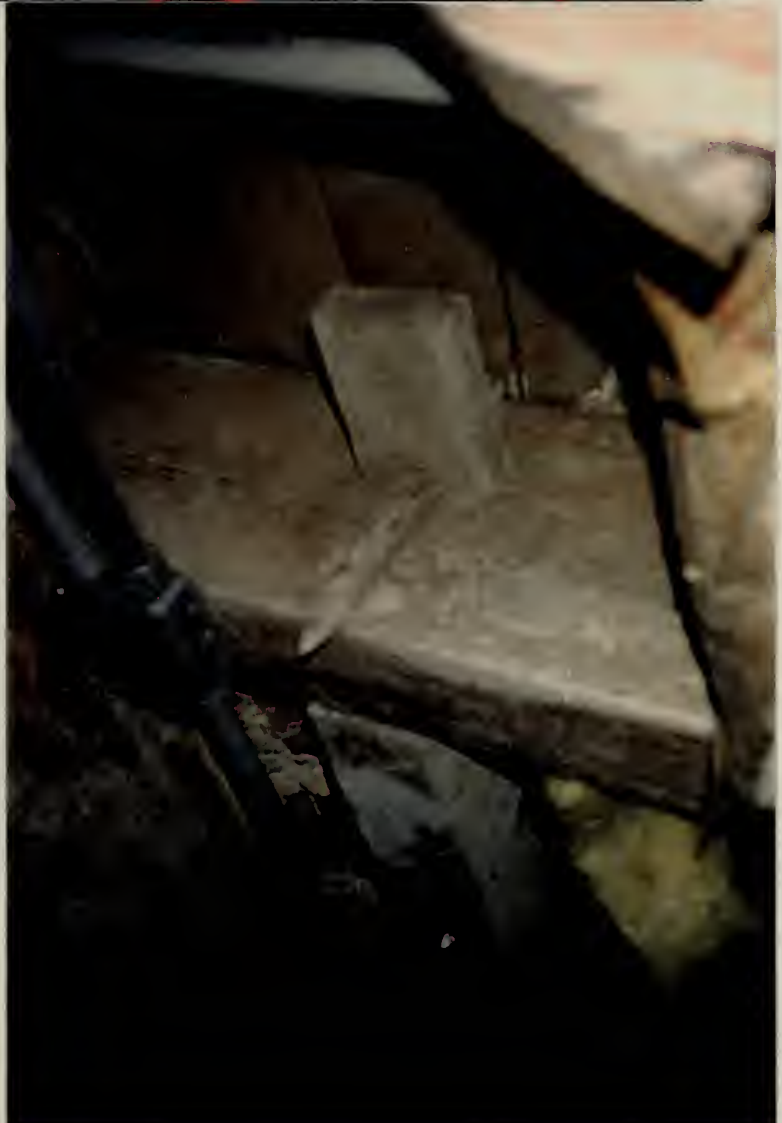
Photo indicates the fireplace foundation in the crawl space and the batt insulation inserted between the joists of the first floor in the main building.

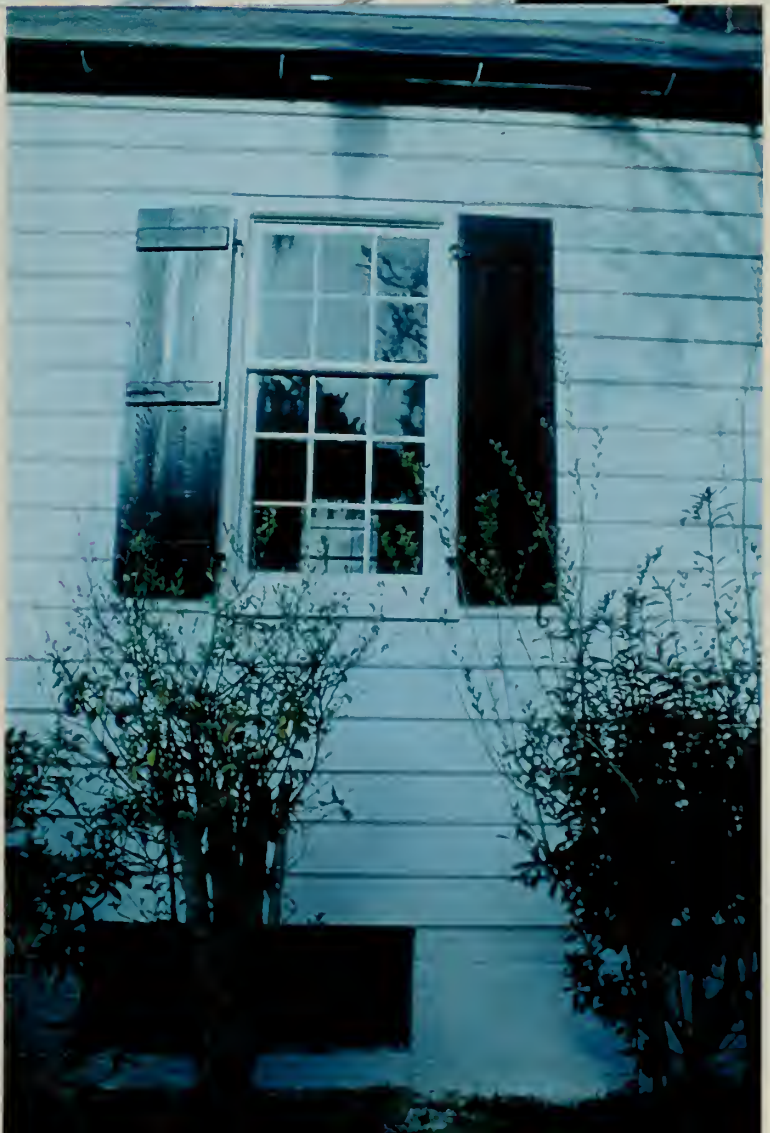
Detail of the double-hung window with board and batten wood shutters in the main building. Most of the first floor window sashes are original judging from the style of the muntin profile and from their construction. The profile is a style found from the beginning of the 19th century until about 1840 (see Chief, Preservation Assistance Report dated April 14, 1992).

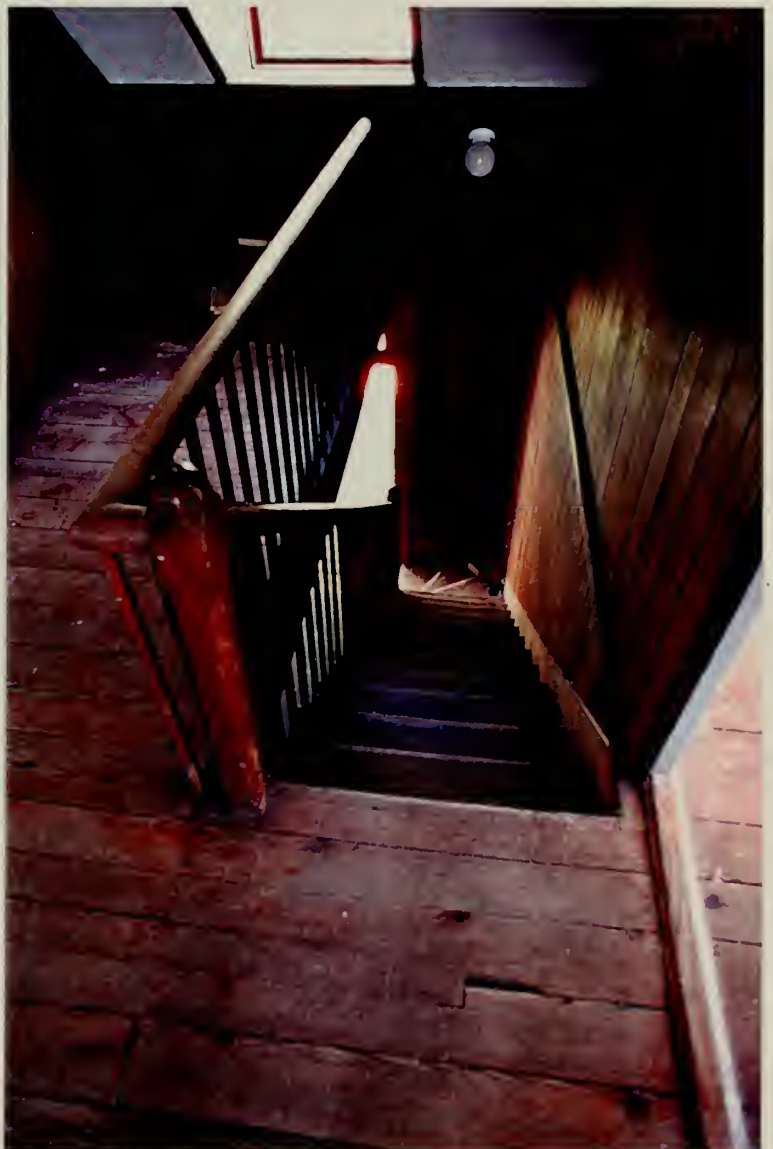
Photo shows the second floor corridor toward the stairs, corridor, and stair railing. The rail in the corridor is not original and was added with wire nails prior to the removal of the hallway paint as evidenced by the paint found below a removed piece of trim fastened with wire nail (see Chief, Preservation Assistance Report dated April 14,1990). Presumably, this rail was added in 1936.

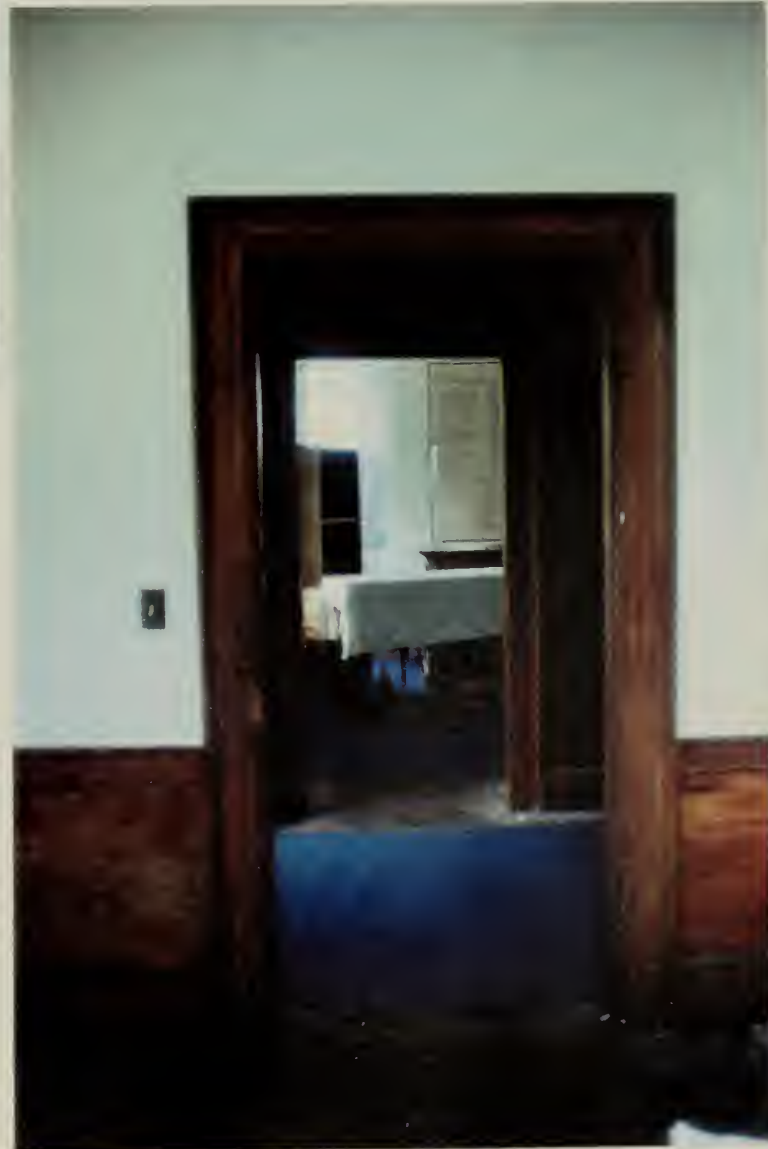
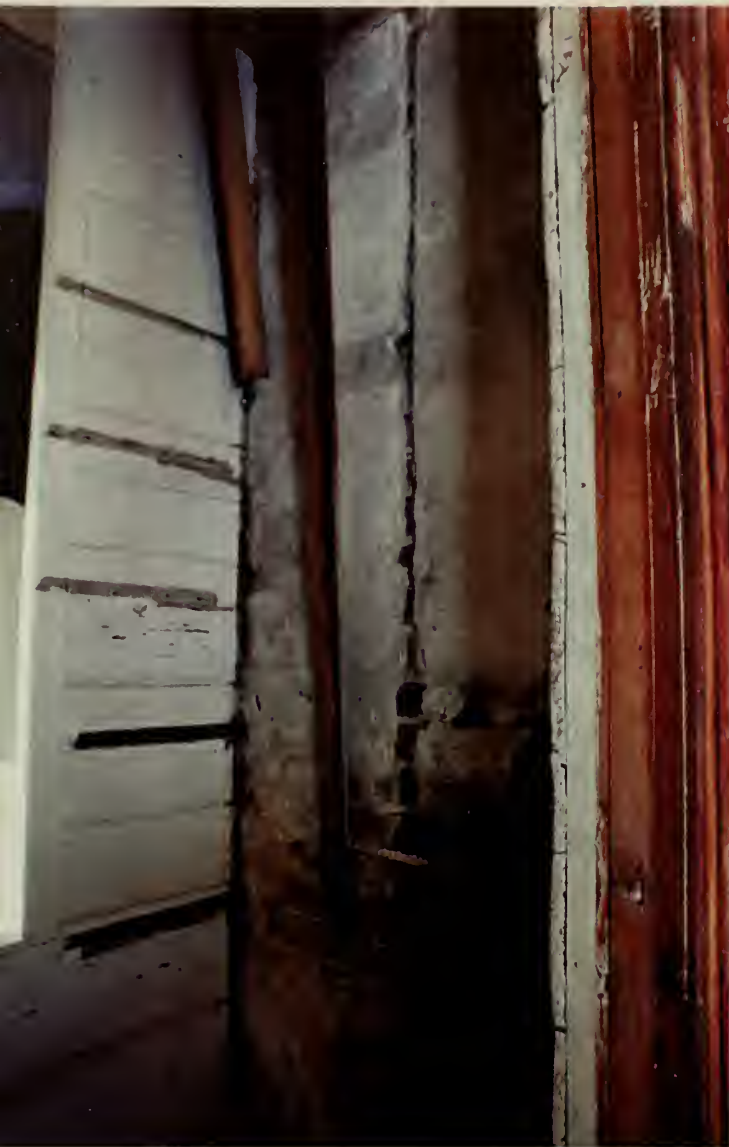
Southwest room door's trim, wainscoting, and baseboard in the main building are painted. Due to lack of a paint analysis, it is not clear if the door trim and wainscoting were originally painted or varnished.

Photo shows the door's wood trim, wainscoting, and baseboard in the southeast room in the main building. Due to lack of a paint analysis, it is not evident if this color is the original color of the door, wainscoting and door trim.

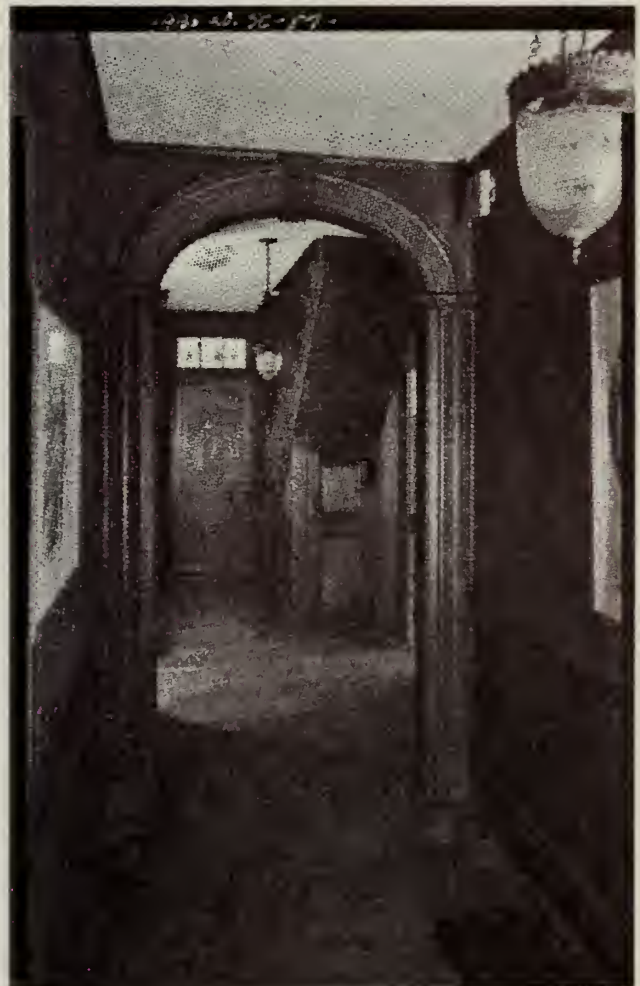
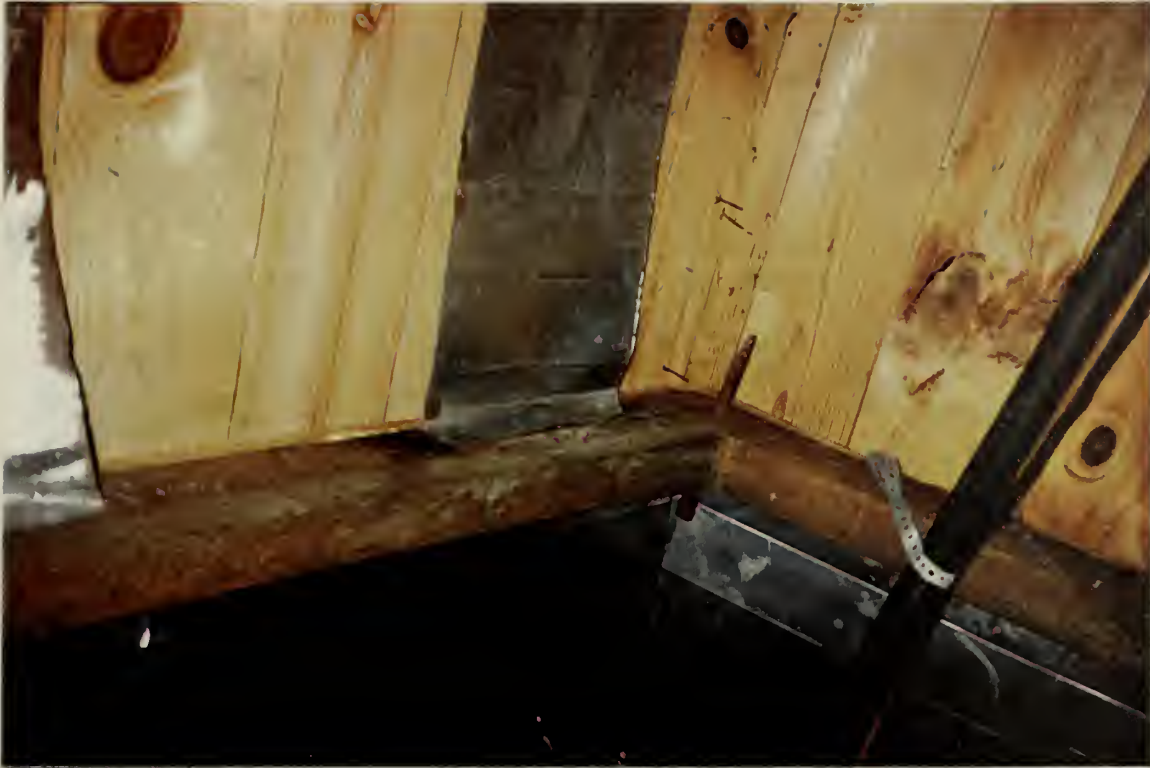
Photos show the decorative elliptical cypress wood archway with symmetrically molded fluted pilaster on the first floor corridor in the main building. The underside of the arch reeded and it is topped with a key stone. Note both chandeliers have been replaced with track lights. It would be more authentic to remove the track lights and install the chandeliers in their original place.

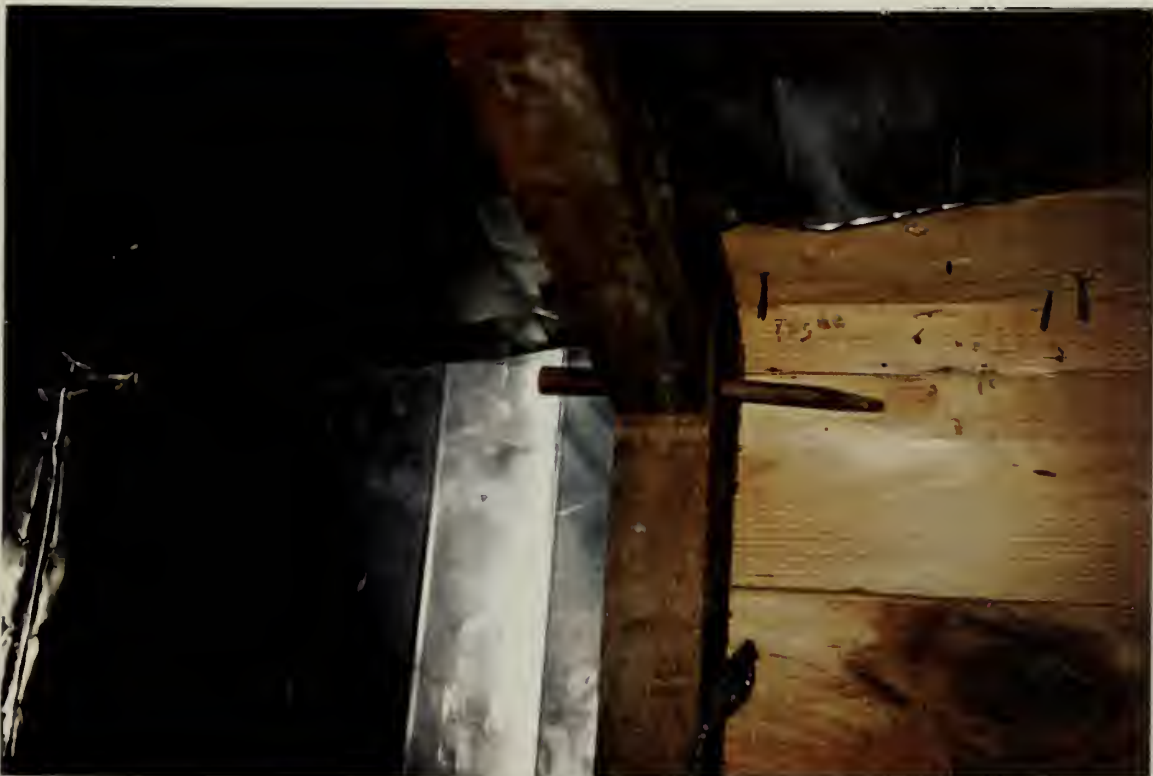
Photo shows the interior part of the main building attic. Note the original wood sheathing and the connection of the rafters. Rafters in the ridge are connected to each other by tenant and mortise with wood peg.

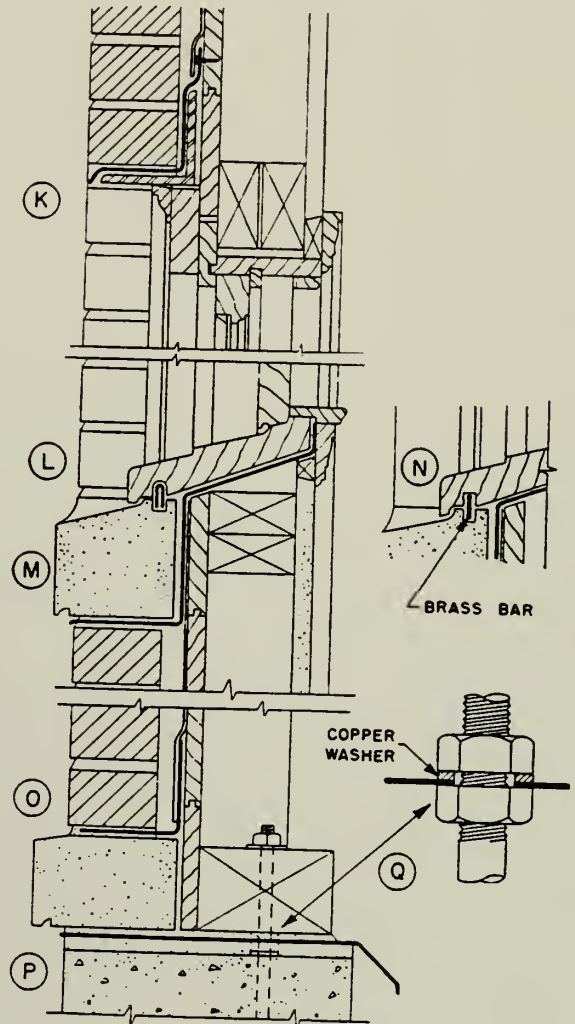
Flashing for window and sill

Some of the existing copper flashing on the dormer sills are not installed in a proper way. This has caused the rainwater to penetrate under the metal flashing through the roof and finally through the ceiling above the north entrance door. See detail C in the appendix.
